## North Coast Regional Water Quality Control Board

### Inspection Report

**Site:** Joseph Stafslie  
**CIWQS Place ID:** 842383 and 842382  
**Inspection Date:** May 23, 2019

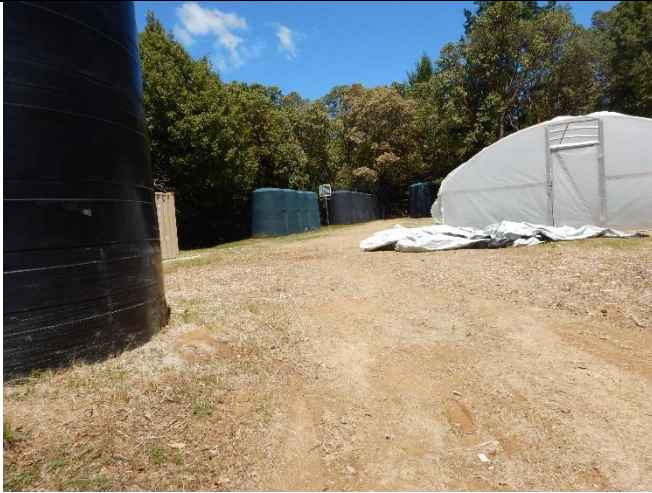
Graded Flat #1, Graded Flat #2, POD #1 in Figure 2 – I observed a well, dozens of water storage tanks, and multiple hoop houses with active cannabis cultivation on graded flats (photo 1). I did not observe erosion or irrigation runoff issues on the flats.

Photo 1 – Graded flat with water storage tanks and hoop houses

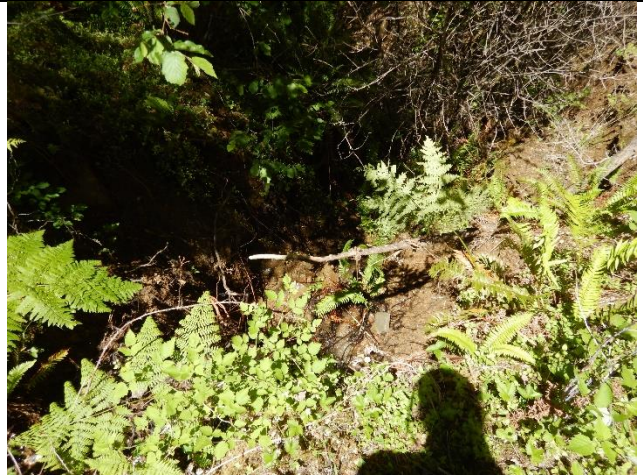
STX 1 in Figure 2 – I observed a culvert stream crossing occluded with sediment and with an outlet perched above the watercourse (photo 2). Replacement to an 18-inch diameter culvert or rocked ford is prescribed in the Site Management Plan (SMP).

Photo 2 – STX 1 – culvert stream crossing

1. Retain a licensed professional to develop a workplan and **schedule** to:
  - a. Decommission or replace failing stream crossings
    - i. Update STX 3 recommendation to at least a 48-inch diameter culvert

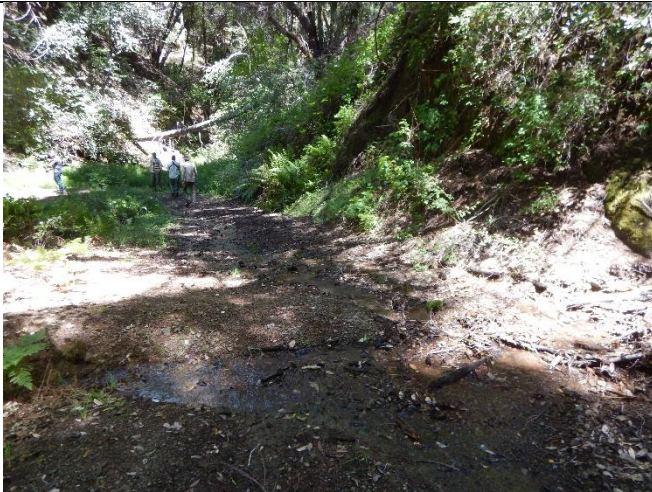
STX 2 in Figure 2 – I observed a dirt ford stream crossing (photo 3). The watercourse was eroding the trail material and conveying it downstream to STX 3. Replacement to an 18-inch diameter culvert or rocked ford is prescribed in the SMP.

Photo 3 – STX 2 – dirt ford stream crossing

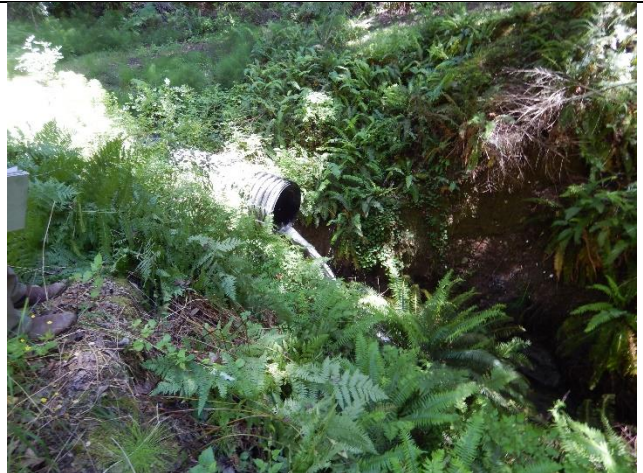
STX 3 in Figure 2 – I observed a 36-inch diameter culvert stream crossing with an outlet perched above the watercourse (photo 4). Replacement to a 42-inch diameter culvert or rocked ford is prescribed in the SMP. I measured an active channel width of 48 inches. I observed road runoff and stream water diverted from the failed STX 2 had channelized down the road and was actively eroding the fill around culvert STX 3, contributing sediment to the watercourse (photo 5).

Photo 4 – STX 3 – culvert stream crossing

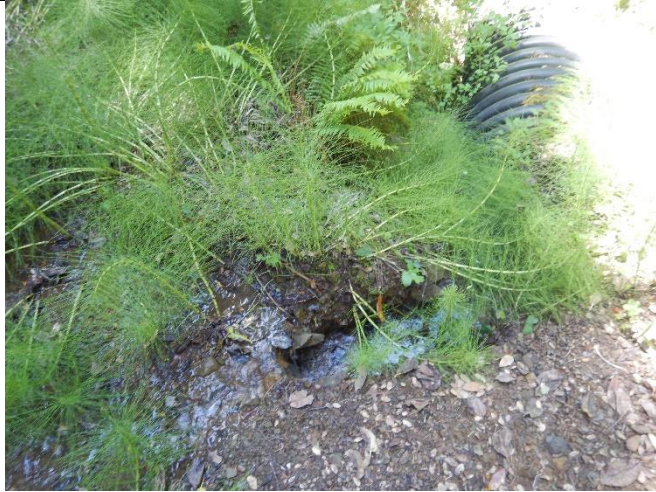
Photo 5 – STX 3 – road runoff and diverted flow from STX 2 eroding culvert fill

- b. Improve road alignment, surfacing, and drainage to minimize erosion and sediment transport. Hydrologically disconnect roads and road ditches from watercourses.

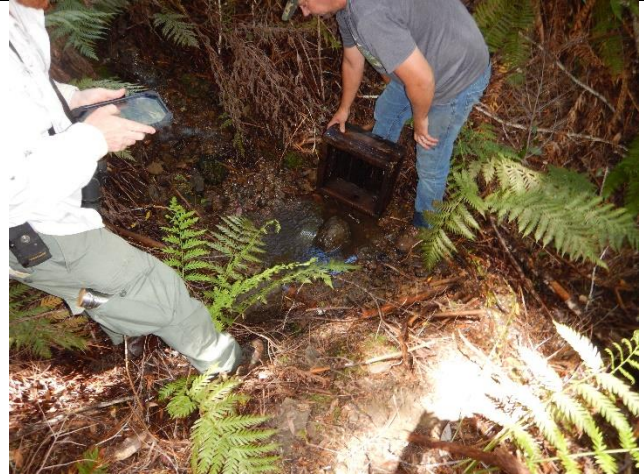
POD #3 in Figure 2 – I observed an intake line with a screen in the pool of a watercourse (photo 6). Directly downstream I observed a settling barrel (photo 7). We discussed in the field moving water diversion infrastructure out of the watercourse to the extent possible.

Photo 6 – POD #3 – screened intake in stream

3. Relocate water diversion infrastructure outside of the active riparian zone to the extent possible
4. Relocate water storage tank to a stable area outside of the required 50-foot riparian setback from the Class III watercourse

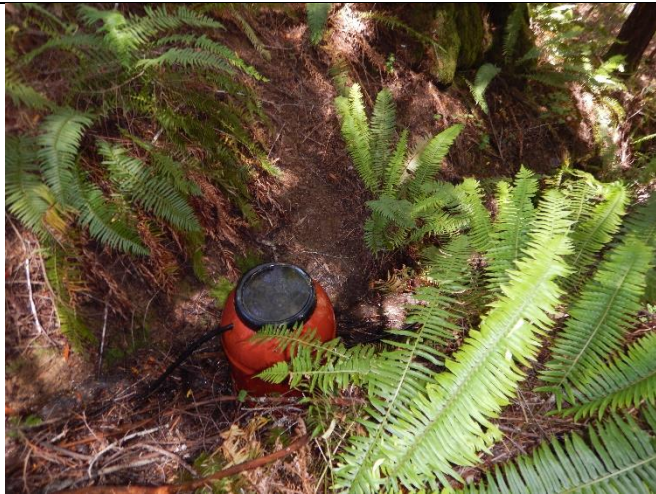
Photo 7 – POD #3 – settling barrel downstream of screened intake

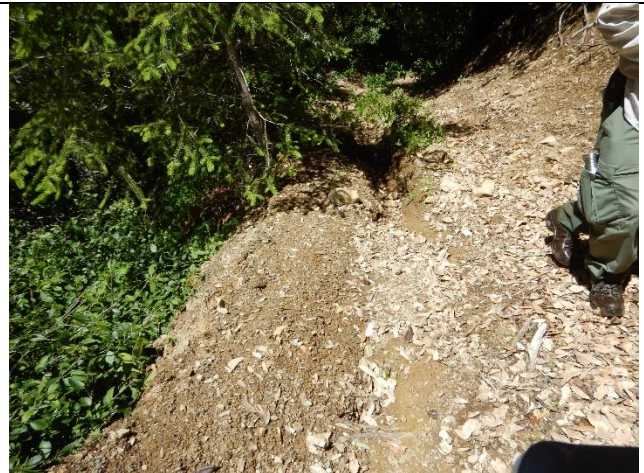
Rut (-123.97307, 40.09232) - I observed a large rut in a road approximately 400 feet south of POD #3 (photo 8).

Photo 8 – Rut – large rut in road

5. Add Rut to SMP and prescribe treatment such as the addition of water bars uphill

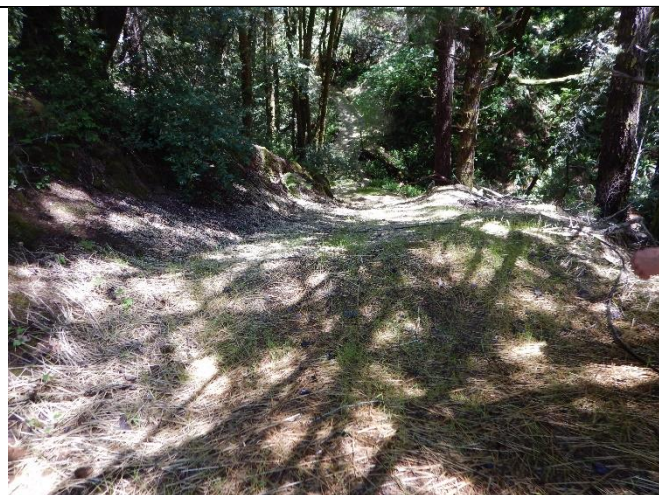
ATV Trail #2 in Figure 2 – I observed the end of ATV Trail #2 that is being decommissioned. The trail was covered in straw and vegetation was reemerging (photo 9). Outsloping and adding drainage relief are prescribed in the SMP.

Photo 9 – ATV Trail #2 – portion of ATV trail being decommissioned and revegetated

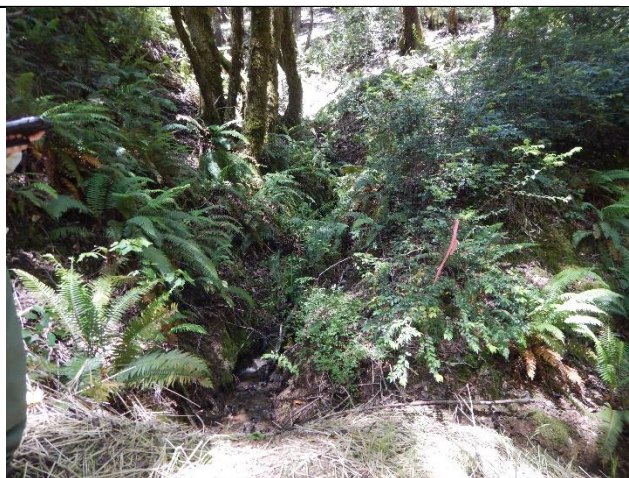
STX 5 in Figure 2 – I observed a culvert stream crossing with a buried outlet (photo 10). Culvert removal and excavation to natural channel gradient is prescribed in the SMP.

Photo 10 – STX 5 – culvert stream crossing

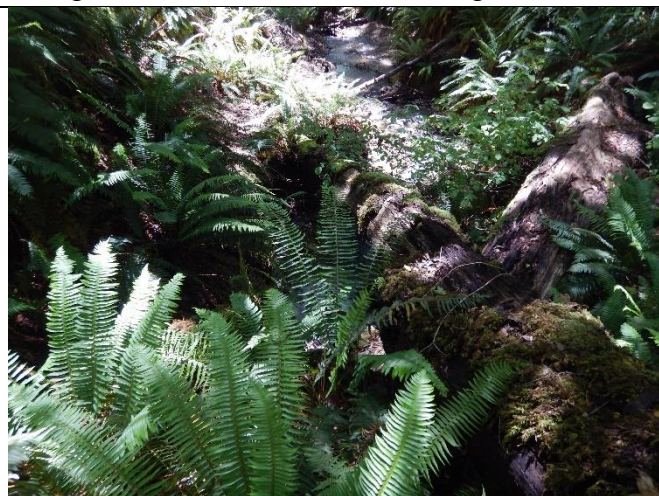
STX 4 in Figure 2 – I observed a 36-inch diameter culvert with an outlet perched above the watercourse (photo 11). Because the culvert was not aligned with the watercourse, the channel bed at the base of the outlet is eroding and transporting sediment downstream. Culvert removal and excavation to natural channel gradient is prescribed in the SMP.

Photo 11 – STX 4 – culvert stream crossing

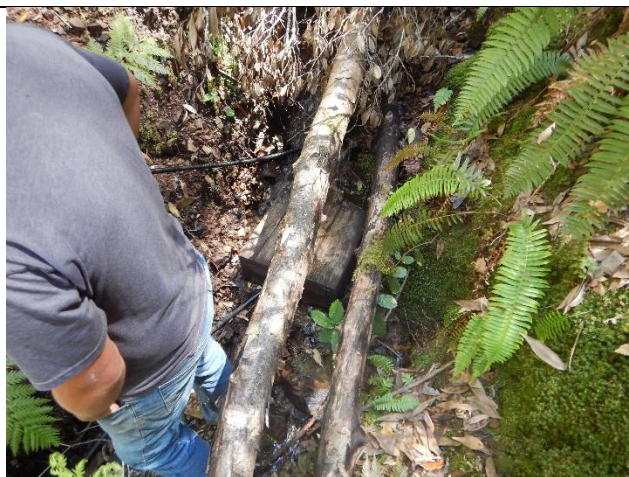
POD #2 in Figure 2 – I observed an intake line with a screen in the pool of a watercourse (photo 12). Directly downstream I observed a settling barrel (photo 13). We discussed in the field moving water diversion infrastructure out of the watercourse to the extent possible. I recorded this point on the eastern parcel boundary, which differs from its location in Figure 2.

Photo 12 – POD #2 – screened intake in stream

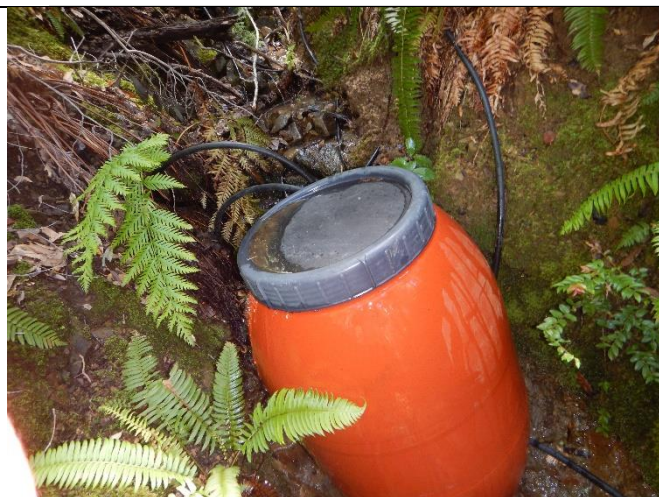
Photo 13 – POD #2 - settling barrel downstream of screened intake

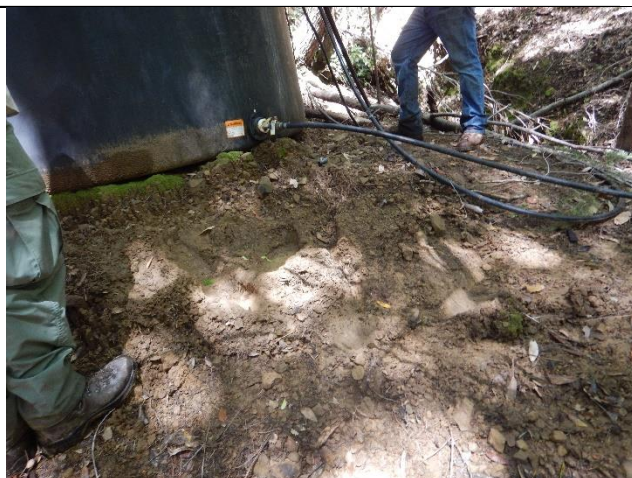
Tank (-123.97034, 40.08340) - I observed a water storage tank on a steep, eroding flat directly above a Class III watercourse (photo 14, 15).

Photo 14 – Tank – looking uphill at water storage tank on steep, eroding slope

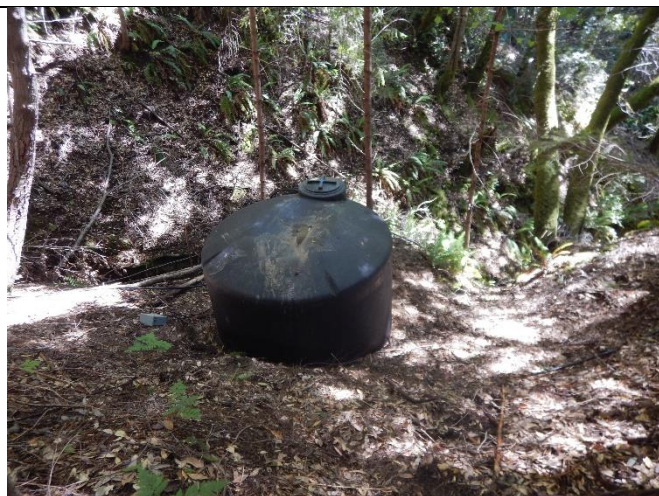
Photo 15 – Tank – looking downhill at water storage tank proximity to watercourse
